Minerals Inspection Report

Mine Name: Butler Valley Quarry	Permit Number: S/025/0016	Mine Status: Reclaimed
Operator Name: Alpine Gems	Inspection Date: 4/27/2015	Permit Fees: No Fee Req.
Inspector(s): Lynn Kunzler	Inspection Time: 2:00 pm	Bond Amount: \$4,500
Attendee(s): Ben Lamoreaux	Weather: clear	Bond Escalation: na
Inspection Purpose: Routine inspection		Prior Inspection: 6/18/2013

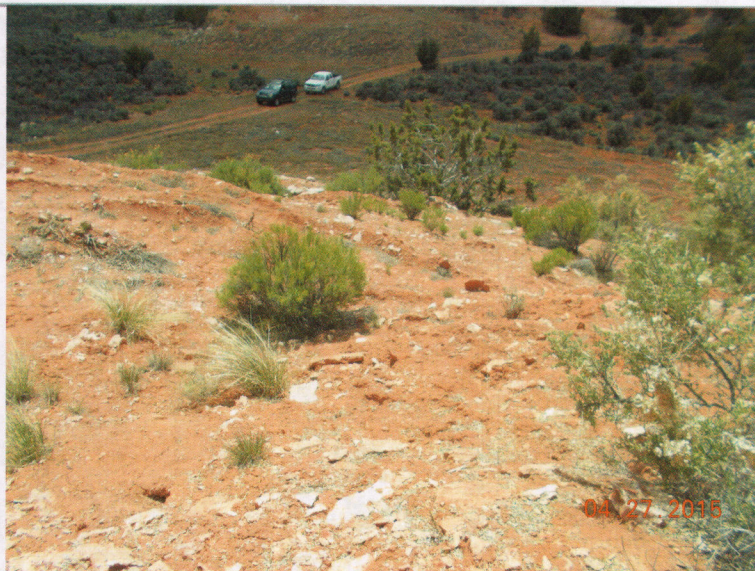
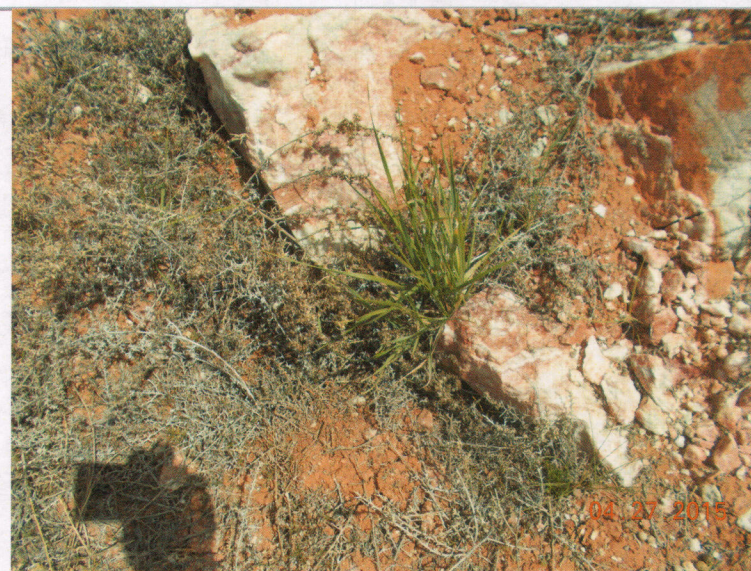
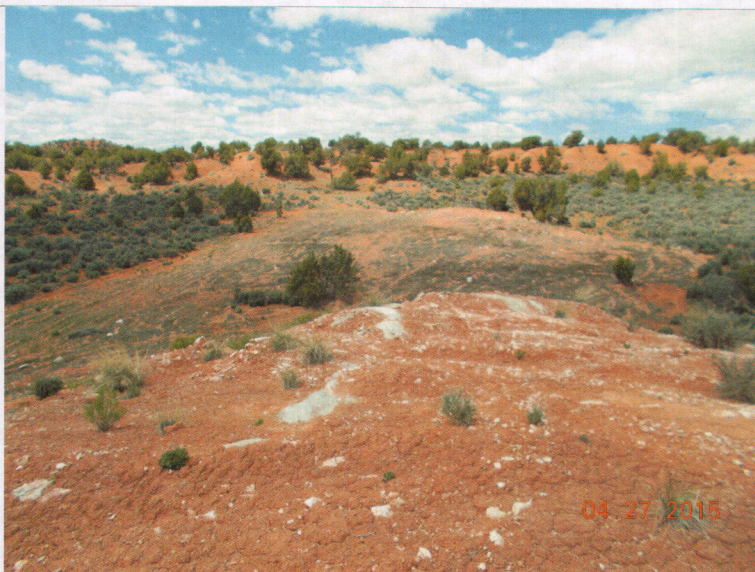
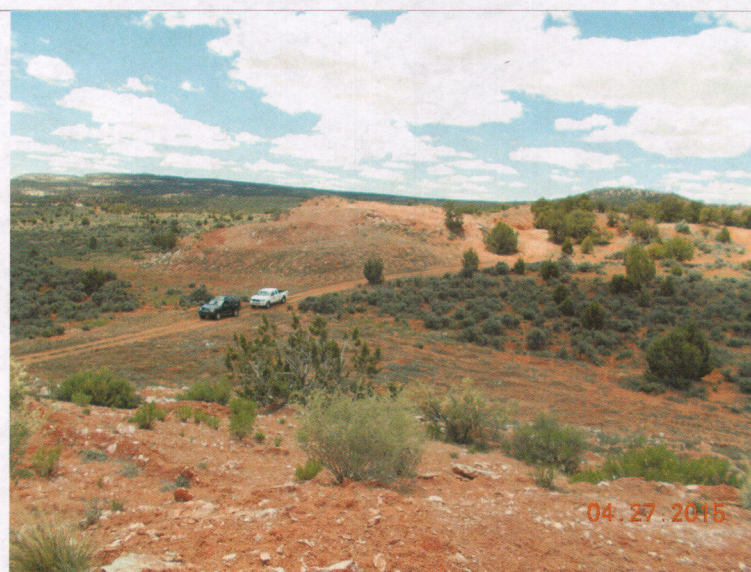
6. <i>Reclamation</i>		<input checked="" type="checkbox"/>	<input type="checkbox"/>
The area is stable and vegetation is establishing, although it is currently only about 60% of the surrounding area. It is believed that with addition time the success standard will be met. This area is also within the Grand Staircase National Monument so it would be difficult to bring in heavy equipment to do any additional work.

While the vegetation success standard has not been met, it is recommended that we consider all practical work has been completed and close the file. The remaining \$4,500 surety should be transferred to the operator's Big Dry Valley Quarry permit, which would make that surety adequate for the current disturbances there.
